# EVIDENCE BOOK

## Infection Control

**NSK**

# DualDefence™

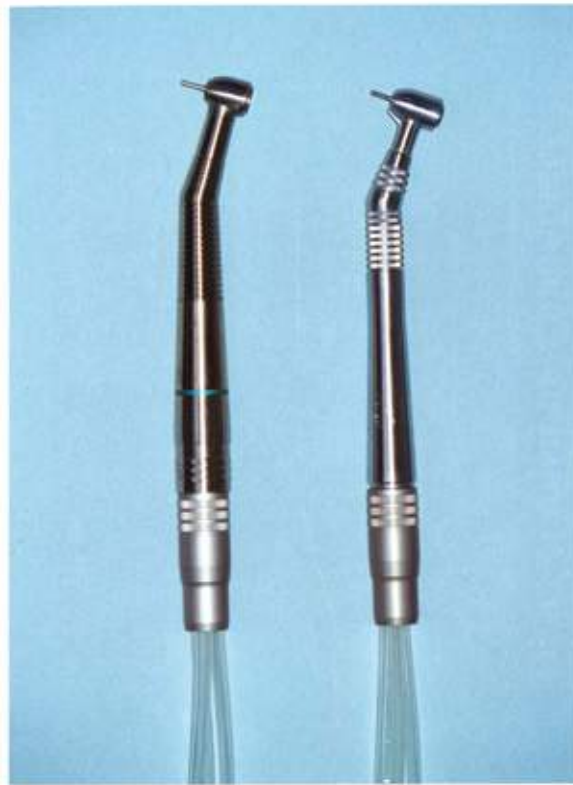
[Fig. 3] Handpieces tested left: new type handpiece with the Labyrinth right: conventional handpiece

The new handpiece with the Labyrinth ( Fig . 3 left ) and a conventional handpiece (fig. 3 right) were tested in this study.

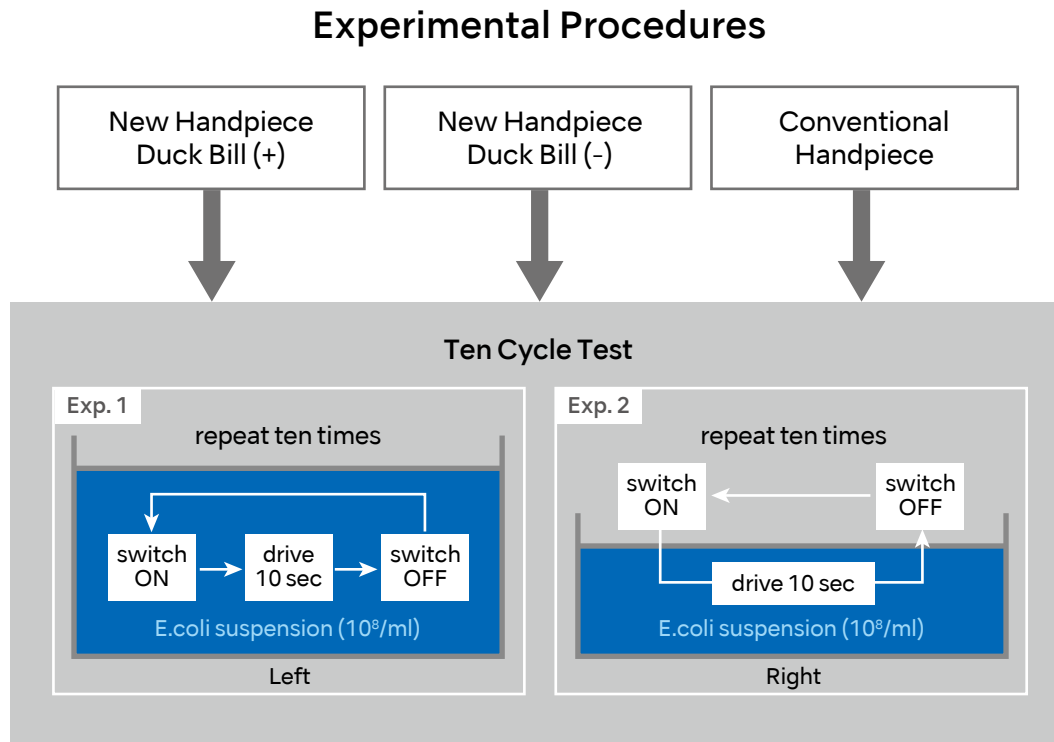
[Fig. 5] Experimental Procedures

In the first experiment (Fig. 5 left), the head of each handpiece was dipped in E.coli-saline suspension, after which the turbine was run for 10 seconds, and switched off. The head was kept in the suspension for 10 seconds. This cycle was repeated ten times per test.

In the second experiment (Fig. 5 right), the unit was run while the head was dipped in suspension, then removed from the solution before switching the turbine off. This cycle was also repeated ten times.

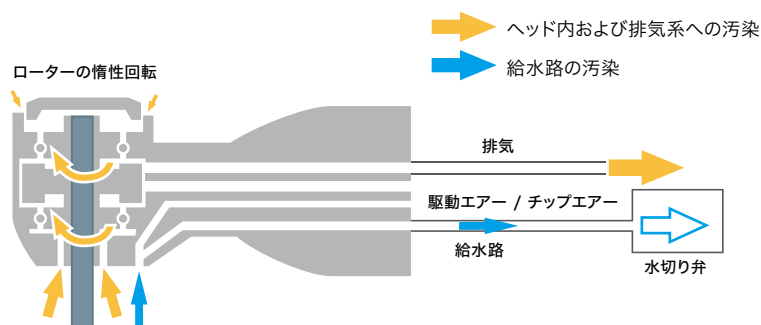
[図1] 汚染物の侵入経路

エアタービン停止後に見られるローターの惰性回転は、タービンヘッド内に陰圧を発生させ、細かい隙間からの汚染物の侵入を助長すると考えられる。ヘッド内に侵入した汚染物の多くは、再駆動によって排出されるが、一部は排気管に運ばれるため、口腔内で駆動と停止を繰り返した場合には、排気系の汚染はユニット側に向かって急速に拡散していくと想像される。また、歯牙や修復物の切削片を含む汚染物(図2)は、オートクレーブ滅菌によってハンドピース内部で焼き付きを起こし、繊細な構造を持つベアリング部の機能異常、耐久性の低下、滅菌効果の低下などにもつながると考えられる。
